Manhole Inspection Summary

Manhole # S33KK_018MH

Insp Date: **12/6/06 7:41 AM**

Location Address: **25 NORTH AVE**

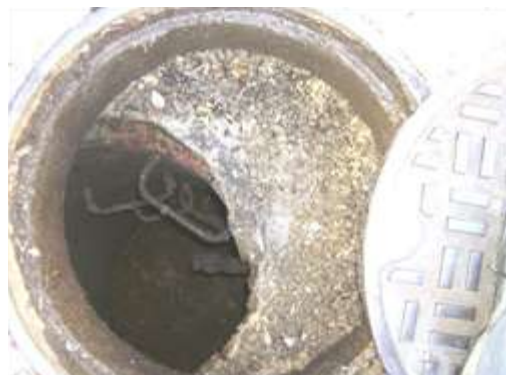
Top View

Offset: **12** (in.)

☒ **Leaks**

Condition: ☐ Sound ☐ Cracked ☐ Root Intrusion ☐ Loose Brick ☒ **Deteriorated**

Infiltration: ☐ None ☒ **Joint** ☐ Cracks ☒ **Mortar** ☐ Roots ☐ Wall

Frame leaks. Frame offset. Adjustment deterioration and infiltration.

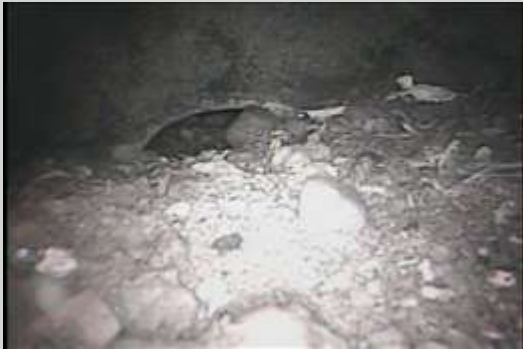
8 in. Circular Gravity Sewer
Pipe Out @ 12 O'Clock

Deposits: ☐ None ☒ **Mud** ☐ Sludge ☒ **Debris** ☐ Grease

Silt Depth: **7** (in.) Deposits Extent: **Heavy**
